Coal Mining Risk Assessment

Client: Lidl Great Britain
Ltd

Commercial Street, Risca

Report No: 1137.04.03

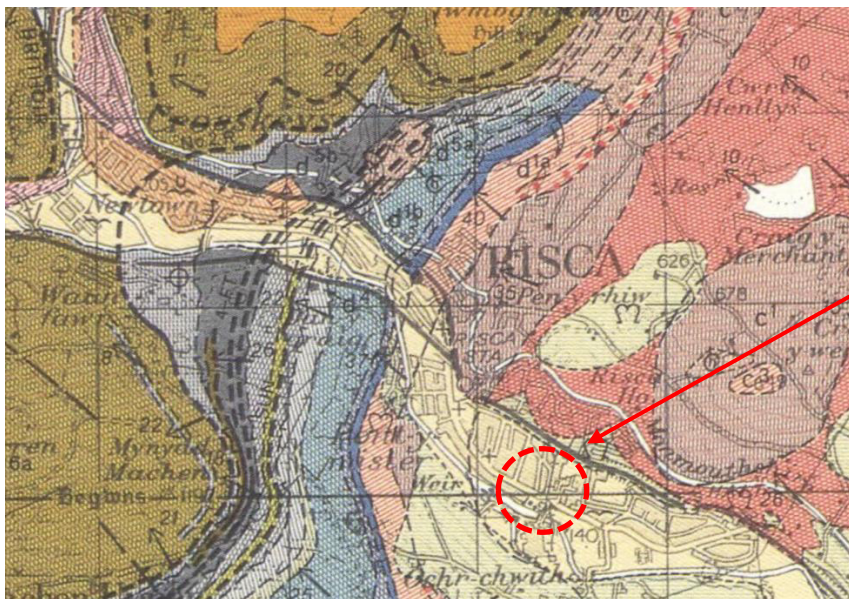
Extract of BGS Sheet 249 – Newport, 1997 (Solid & Drift)

3.2.1 Made Ground and Superficial Geology

The BGS records indicate that there are no Made Ground deposits beneath the site. The on-site superficial deposits are indicated to comprise Alluvium, which the BGS describes as typically comprising 'soft to firm consolidated, compressible silty clay, but can contain layers of silt, sand, peat and basal gravel. A stronger, desiccated surface zone may be present.'

3.2.2 Bedrock Geology

The bedrock underlying the superficial deposits is formed of the St Maughans Formation. The BGS describes the stratum as typically comprising 'interbedded purple, brown and green sandstones and red mudstones with intraformational conglomerates containing calcrete clasts'.

There are no faults, fissures or breaklines recorded within proximity to the site.
