Phase 1 Site Investigation
& Preliminary Risk
Assessment

Client: Lidl Great Britain
Ltd

Commercial Street, Risca

Report No: 1357.01.02

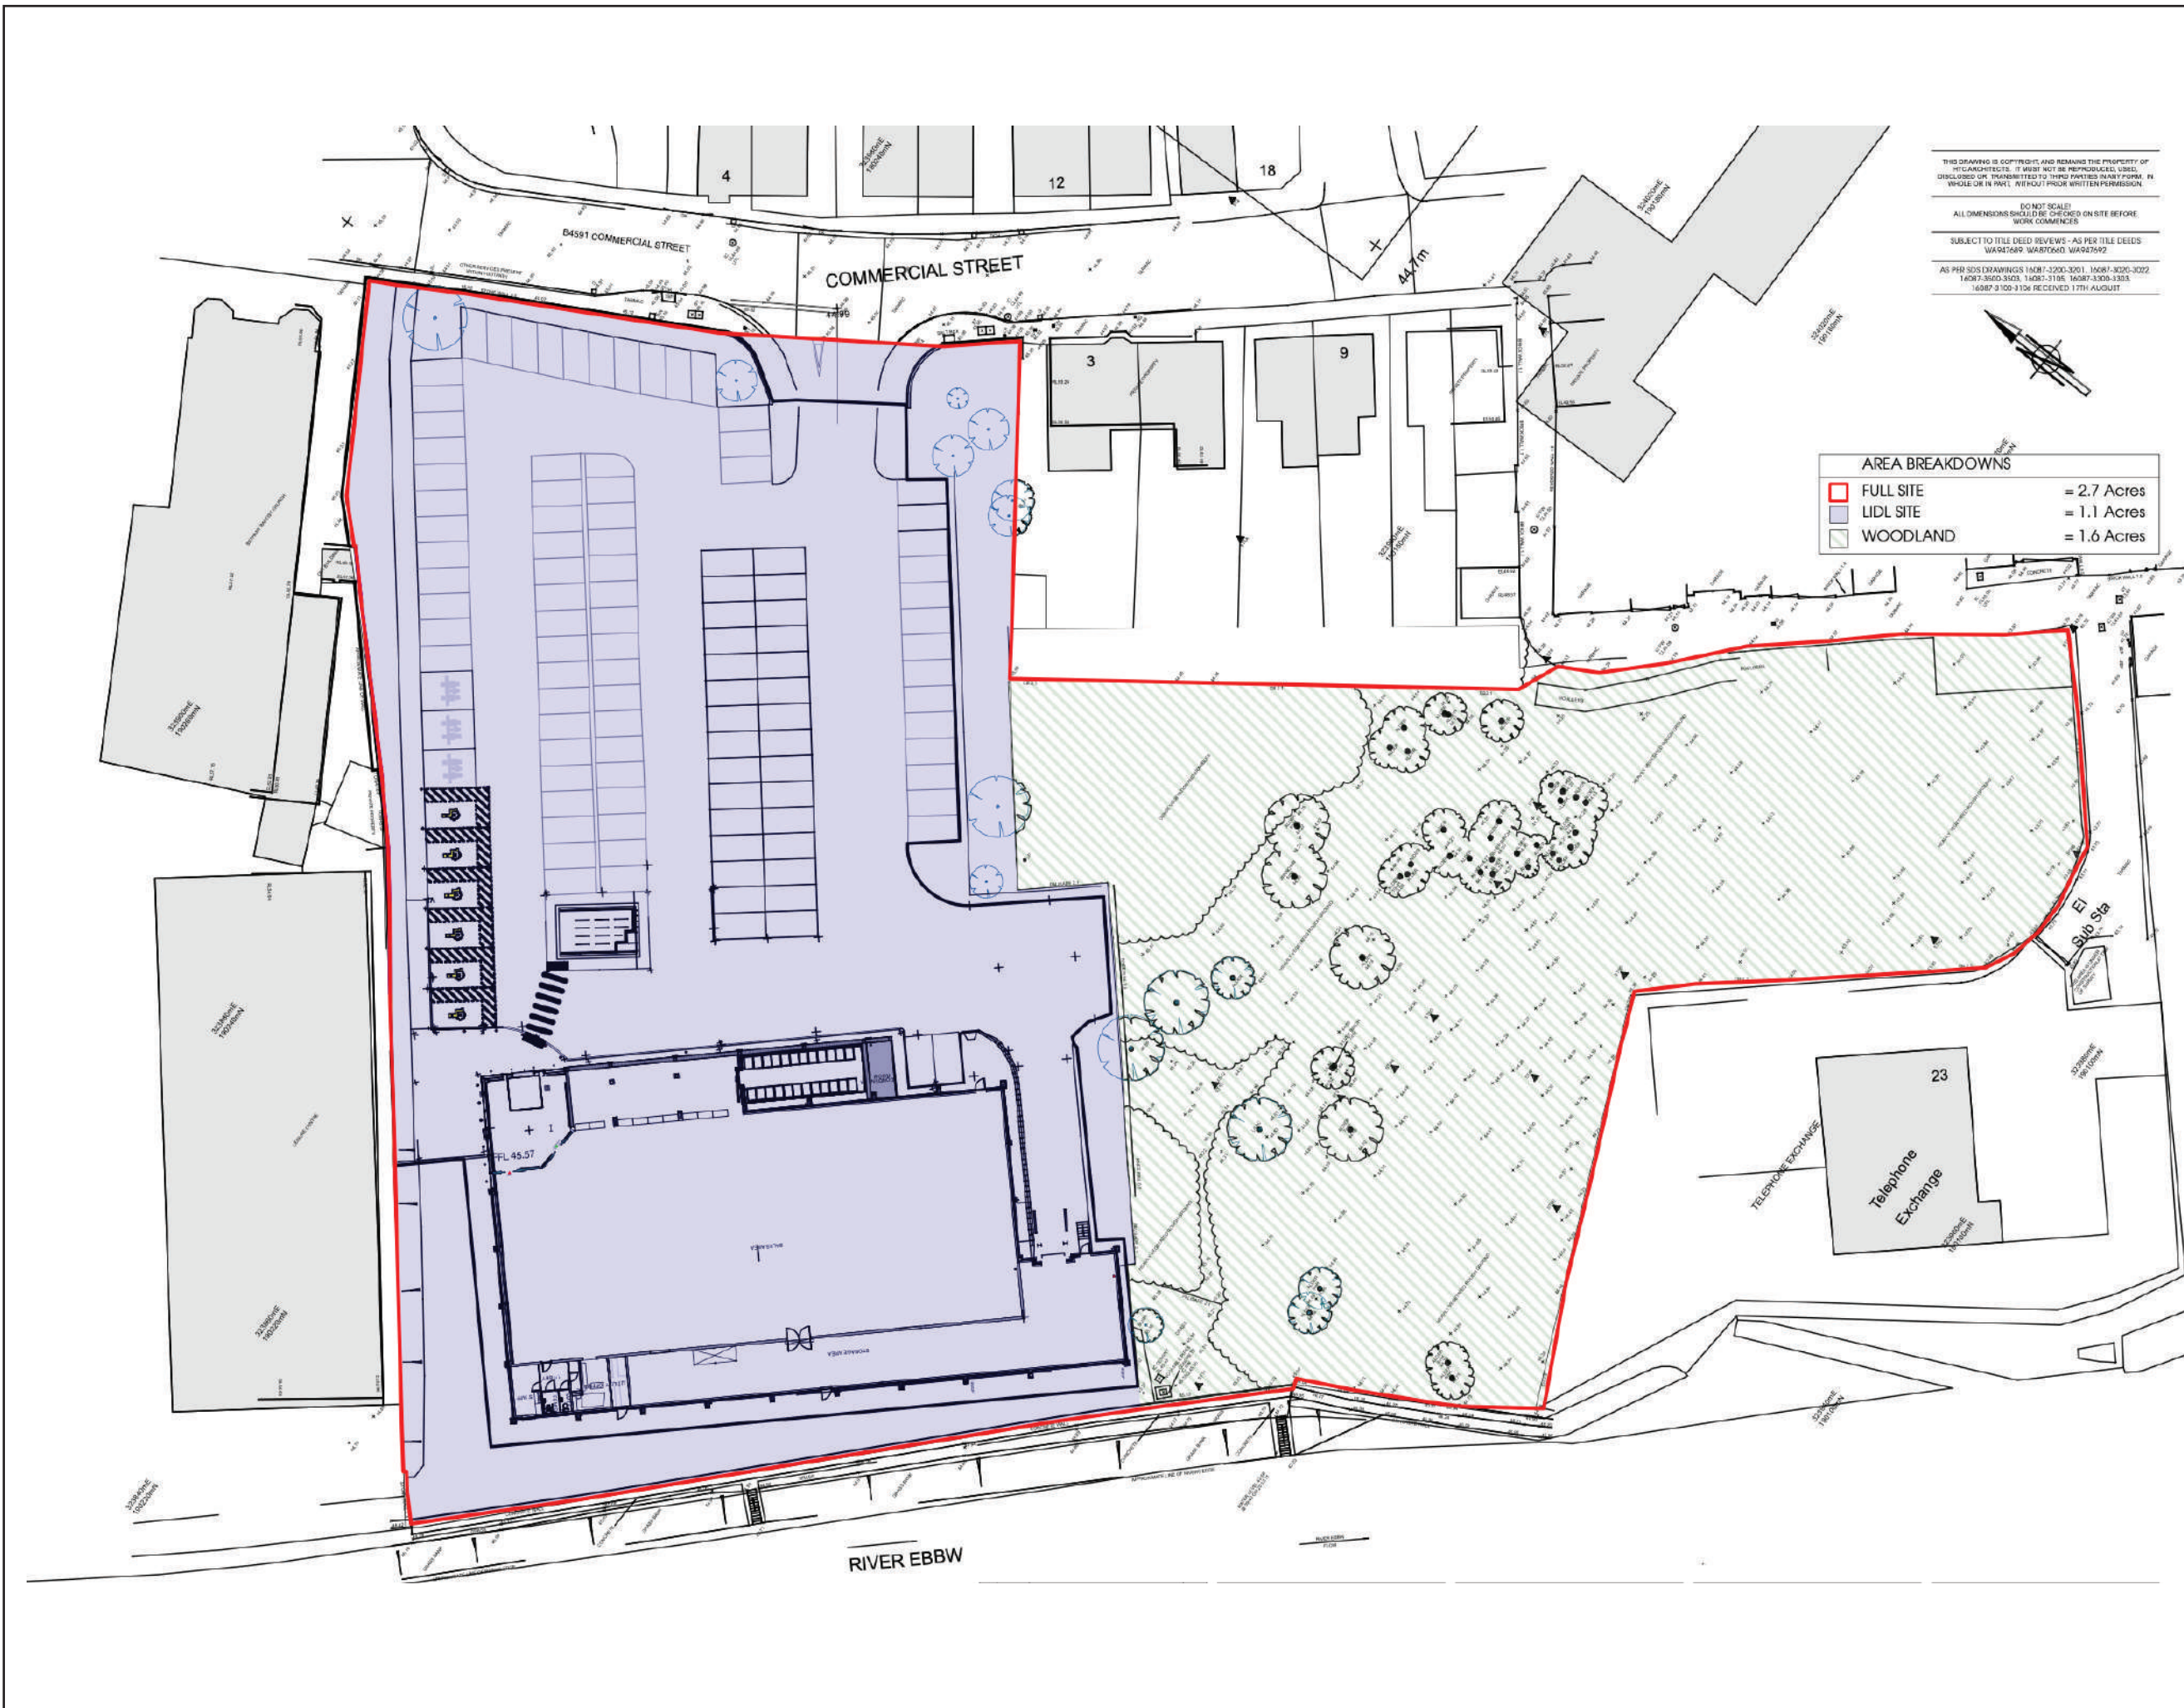
Existing site layout reproduced from client's supplied HTC Architects' Existing Site Plan with Title Deeds drawing, ref: 2966_F411 Rev B dated August 2023.

Site Description The site occupies an irregular plot to the south-west of B4591 Commercial Street, as indicated in **Figure 2**. The site can be divided into two distinct plots, comprising an existing Lidl store and associated car park in the western and northern areas respectively, and scrubland / woodland occupying the southern and eastern areas. The site is divided into two by a metal palisade fence.

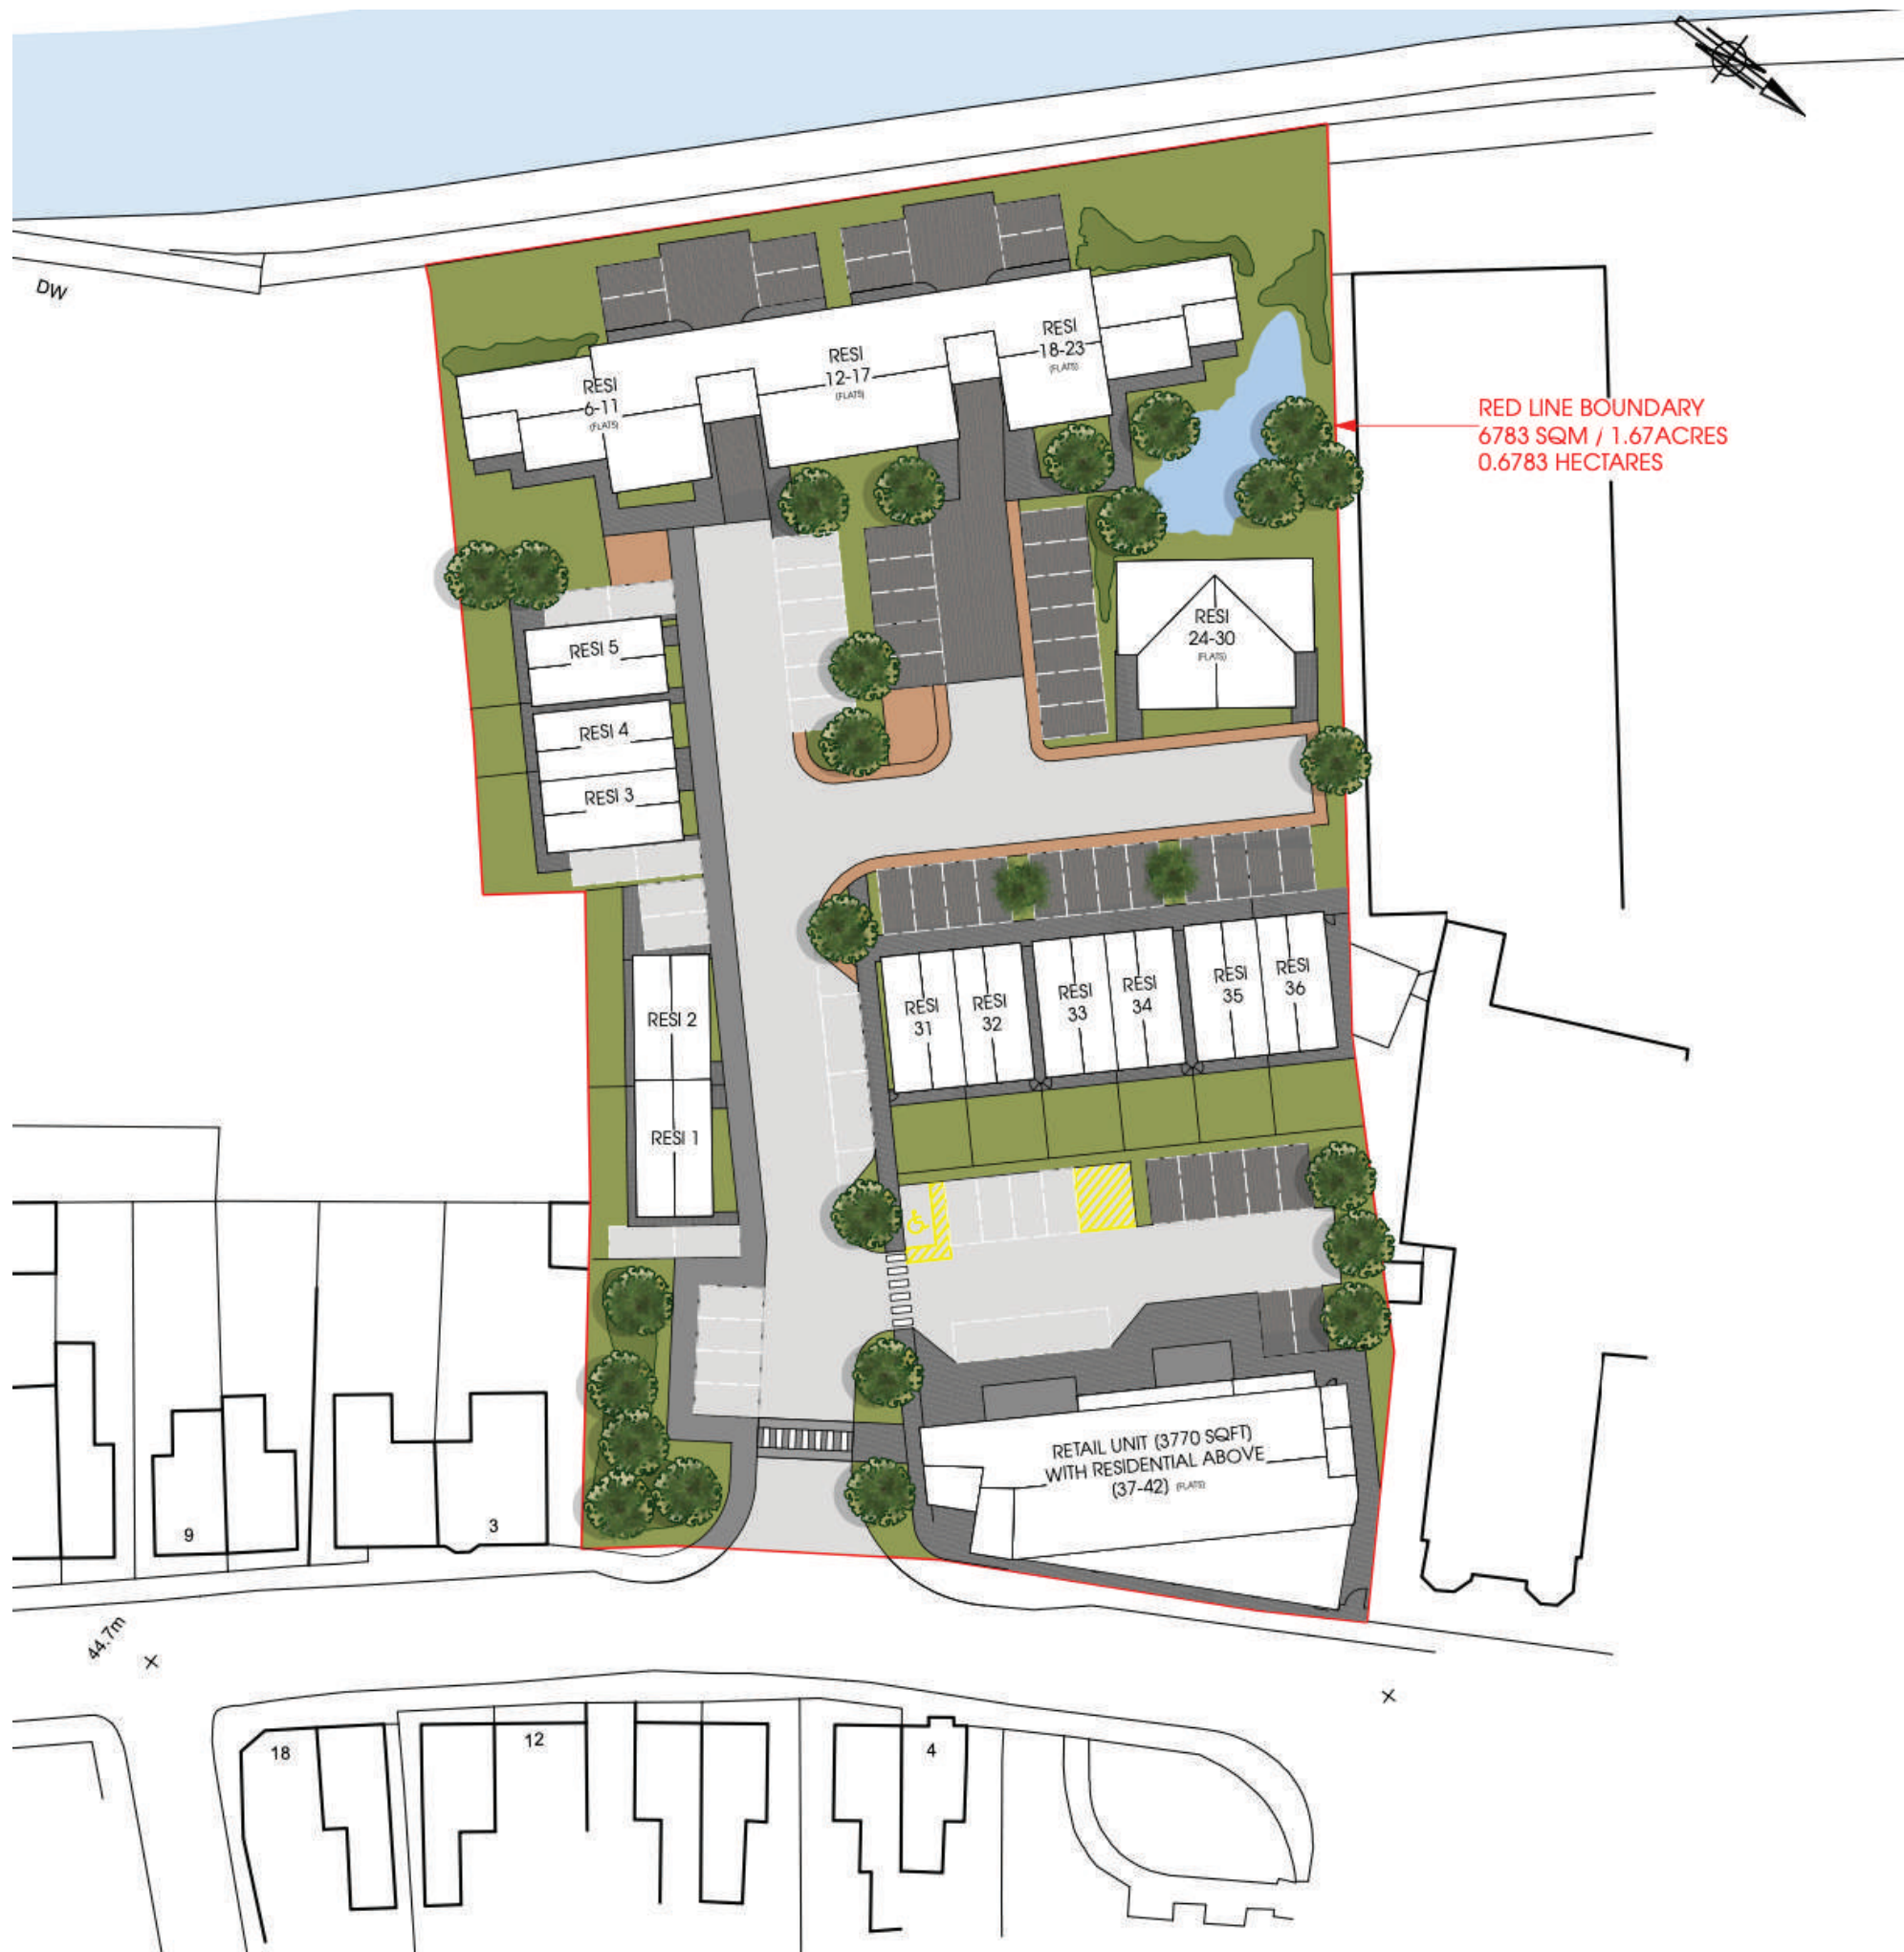
Proposed site layout reproduced from client's supplied HTC Architects' GA Illustrative Site Layout, drawing ref: 2966_P411 Rev B, dated August 2024.

It is understood that the proposed site use for the existing Lidl store area will be for predominantly residential end-use with associated parking and access road. A retail unit is indicated to be present in the north of the site, fronting onto Commercial Street, with residential properties above. A proposed indicative site layout plan is presented as **Figure 3**. The southern half of the site remains unchanged.
