**Phase 2
Ground Investigation**

**Client: Lidl Great Britain
Ltd**

Commercial Street, Risca

Report No: 1137.03.03

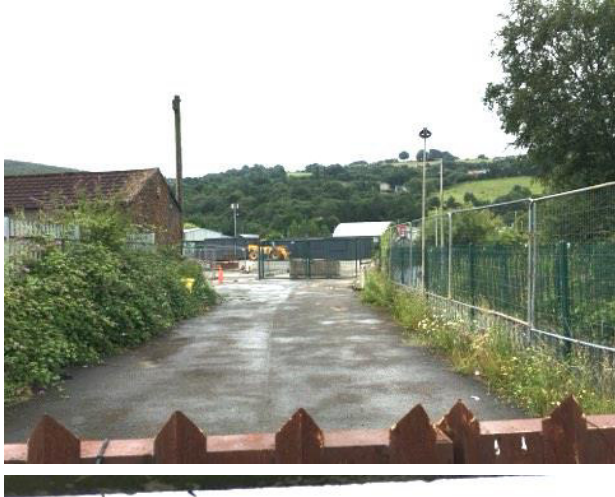
Photo 1: Taken from site entry on Commercial Street facing south, asphalt surfacing present. Signage on the gate, indicates that the site is used as storage yard by Thames Valley Builders.

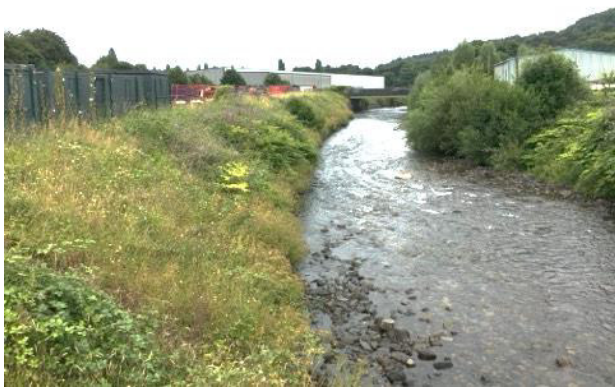
Photo 2: Taken from pedestrian footbridge over Ebbw River facing east. Fencing surrounding site parallel to river at top of sloping bank. Note: Water appeared to be very clear.

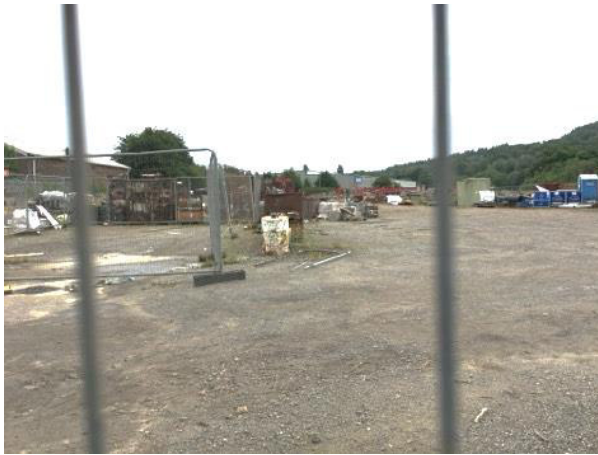
Photo 4: Taken through fence showing main area of site, spill kits evident, uneven made ground, with evidence of rubble from potential demolition in the background.

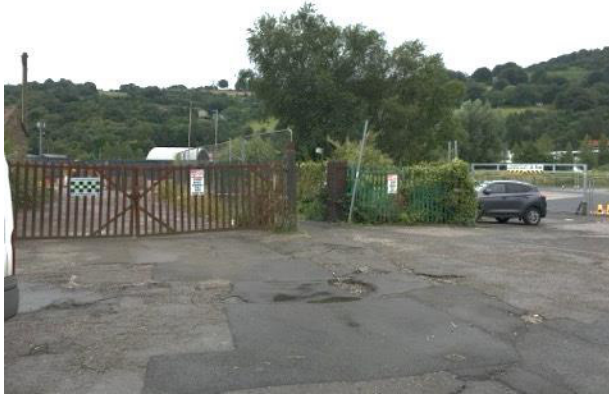
Photo 5: Access entry to site and public footpath leading to bridge over Ebbw River, with evidence of fresh surface laid on site to the west (right side of image)

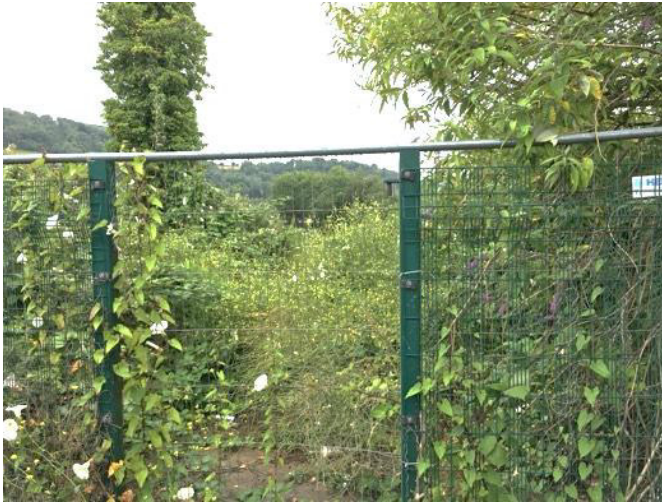
Photo 7: Evidence of overgrown vegetation in area on west side of public footpath

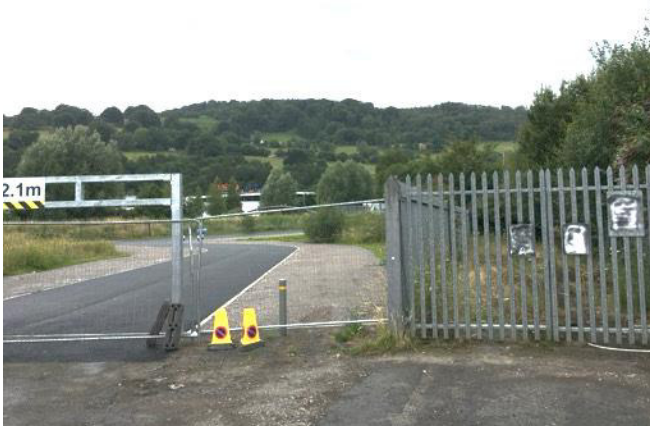
Photo 9: Plot of land to the west with freshly laid road surface.

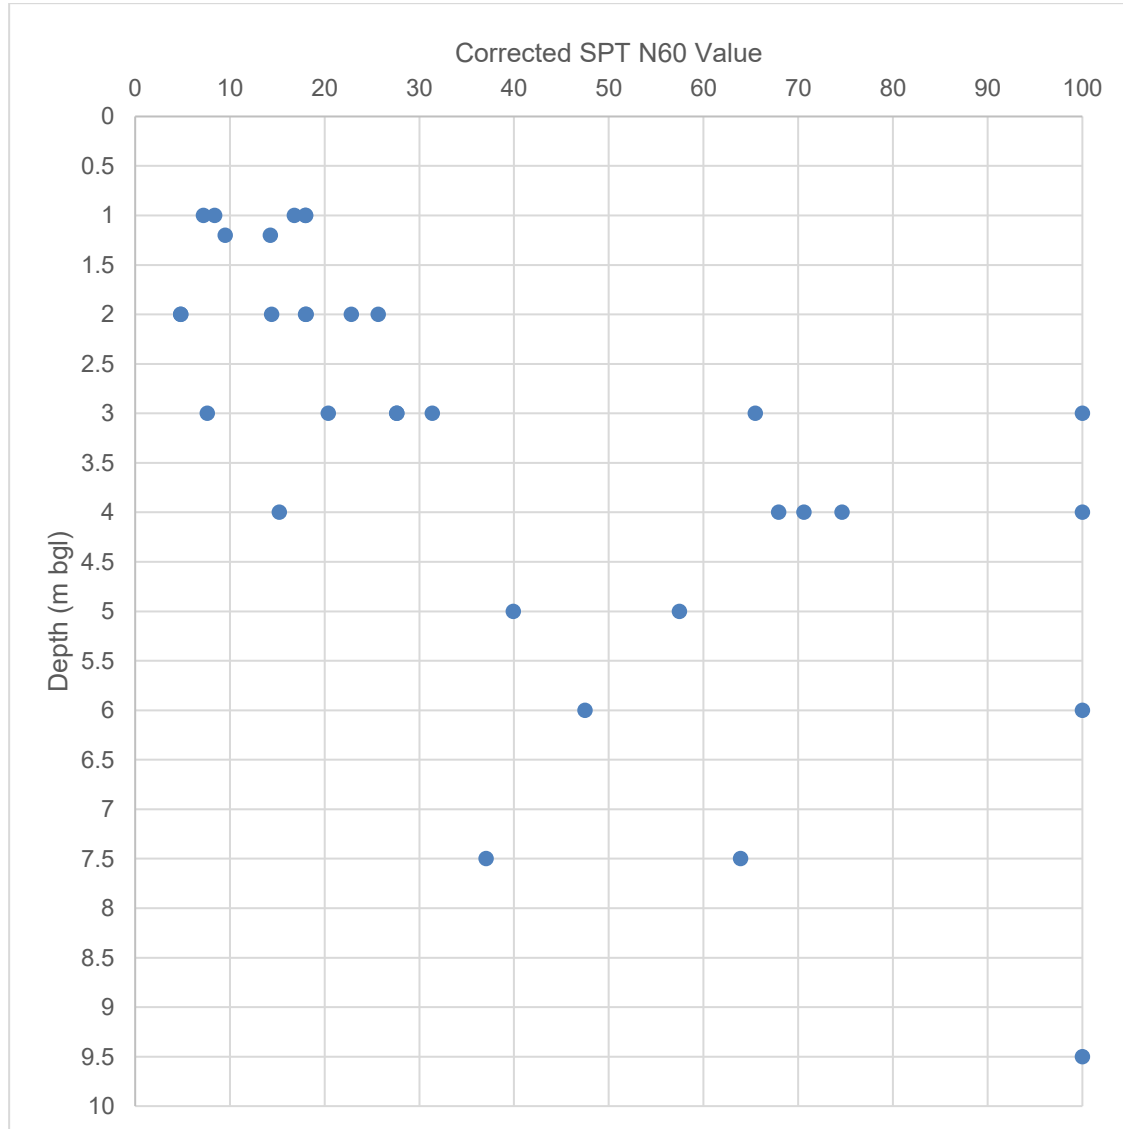
Graph 1: Plot of Corrected SPT N-Values Versus Depth

In-situ SPTs were undertaken to assist with the interpretation of strata encountered. The results of corrected N-values versus depth are plotted in the graph below:

The plot of SPT N values versus depth at **Graph 1** illustrates the variability in strength of the Made Ground fill at the site. As a guide, an N Value of 5 in granular soil would provide an allowable bearing capacity of 50 kPa and therefore either improvement of the Made Ground would be required or piled foundations through the Made Ground would be required to support the proposed store. Piled foundations would be required if proposed foundations were to influence the slope that that forms the riverbank.

Given that the proposed store footprint is not situated directly adjacent to the riverbank, the granular Made Ground could be excavated, processed and recompacted to achieve the bearing capacity required by the engineer for a raft foundation.

The plot of SPT N values versus depth illustrates the variability in strength of the Made Ground fill at the site and therefore either improvement or piled foundations would be necessary to support the proposed store. Piled foundations would be required if proposed foundations were to influence the slope that that forms the riverbank.

Given that the proposed store footprint is not situated directly adjacent to the river bank, the granular Made Ground could be excavated, processed and recompacted to achieve the bearing capacity required by the engineer for a raft foundation.
