Phase 2 Ground
Investigation

Client: Lidl Great Britain
Ltd

Penmaen Road,
Blackwood

Report No: 1271.03.01

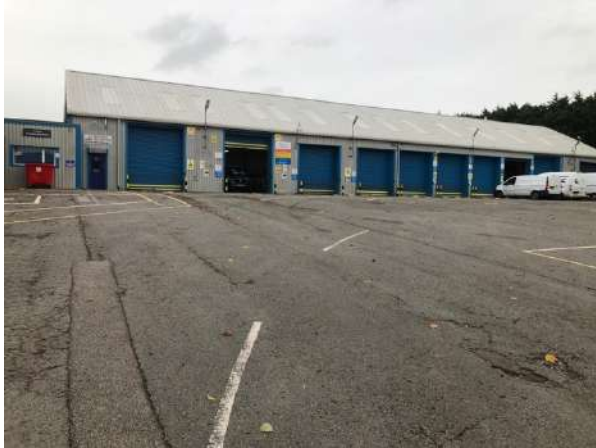
Photo 1: A view north showing the existing bus depot, taken from the centre of the proposed store.

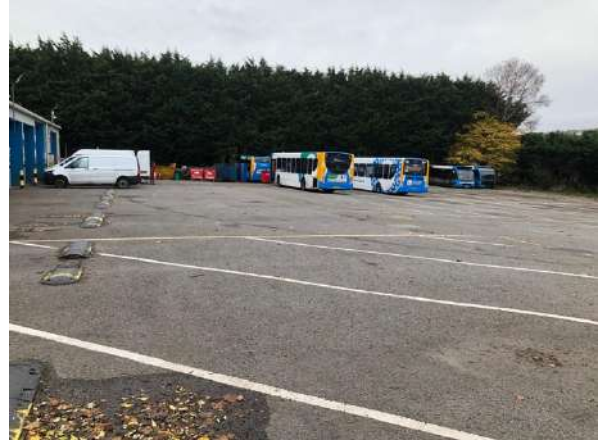
Photo 2: A view towards the eastern boundary of the site, which is marked by the trees in the back of the photo. The sloping from the north to the south is evident from the left of the photo to the right.

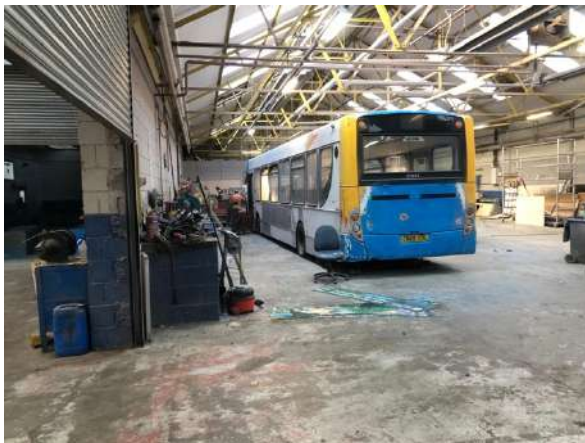
Photo 3: Photograph displaying the rear of the bus depot, where a body shop is located, in the northernmost section of the site, view looking west (taken from the centre of the northern section of the site).

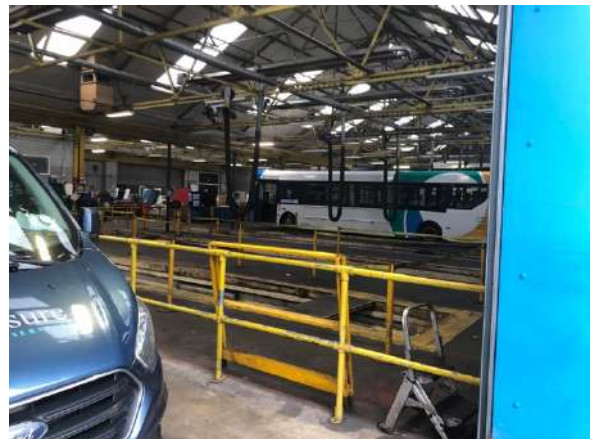
Photo 4: A view eastward of the bus depot, photograph taken from the entrance of the bus depot (located along the south wall of the depot).

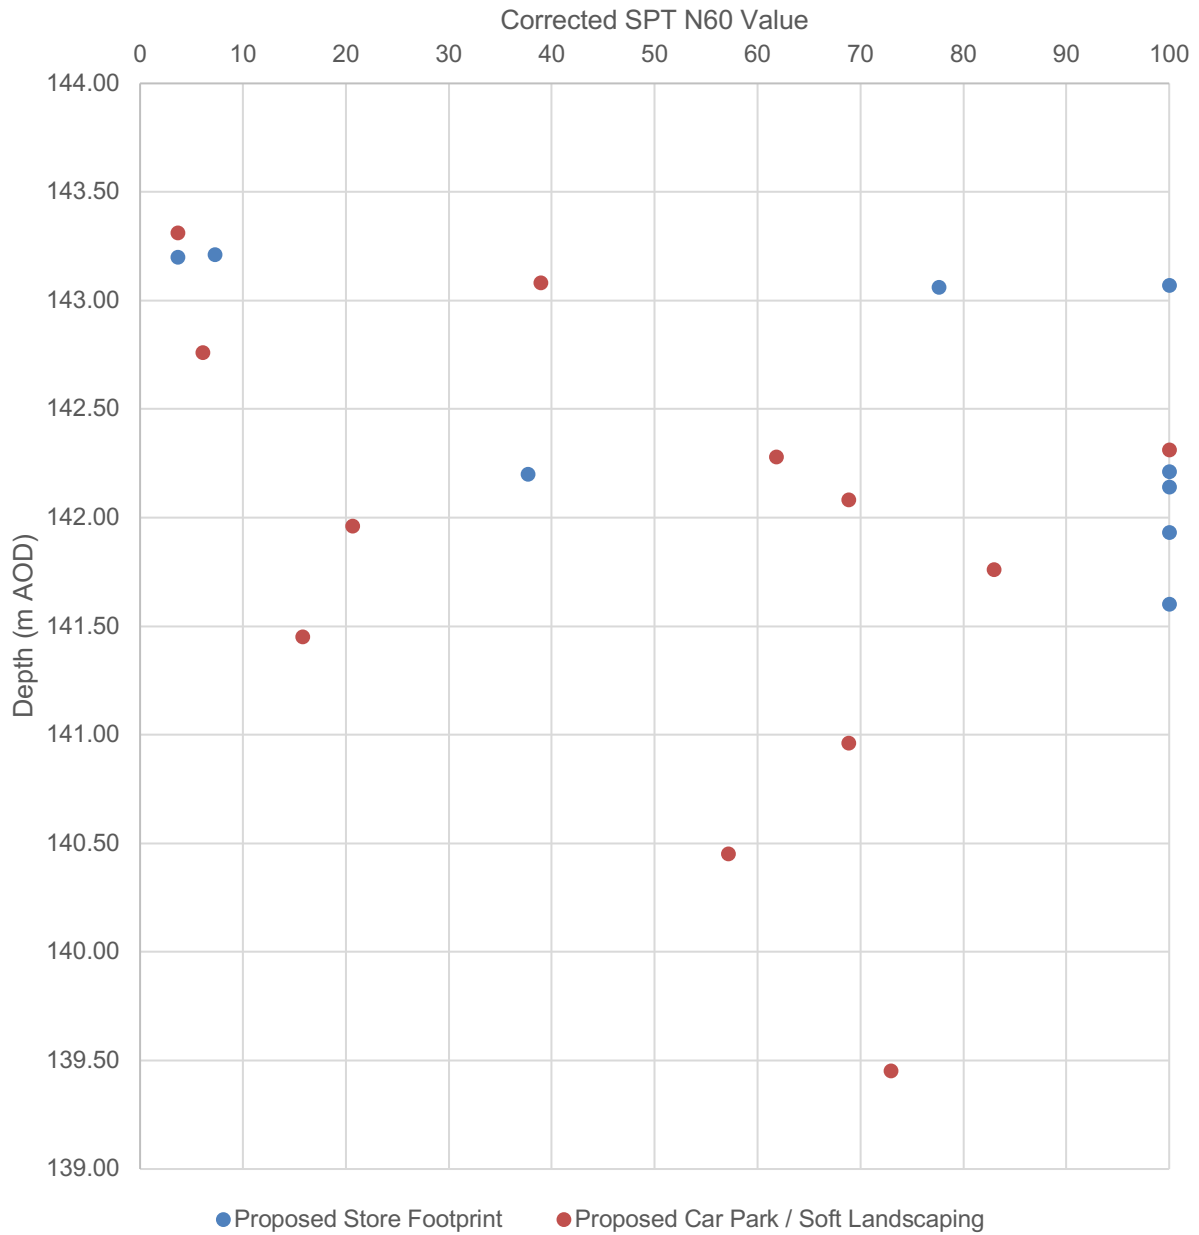
In-situ SPTs were undertaken to assist with the interpretation of the strata encountered. The results of corrected N-values versus depth are plotted in the graph below. Where the corrected N60 value >100, a value of 100 has been plotted.

Graph 1: Plot of Corrected SPT N-Values Versus Depth

Note: Corrected N value plotted at a maximum of N = 100.

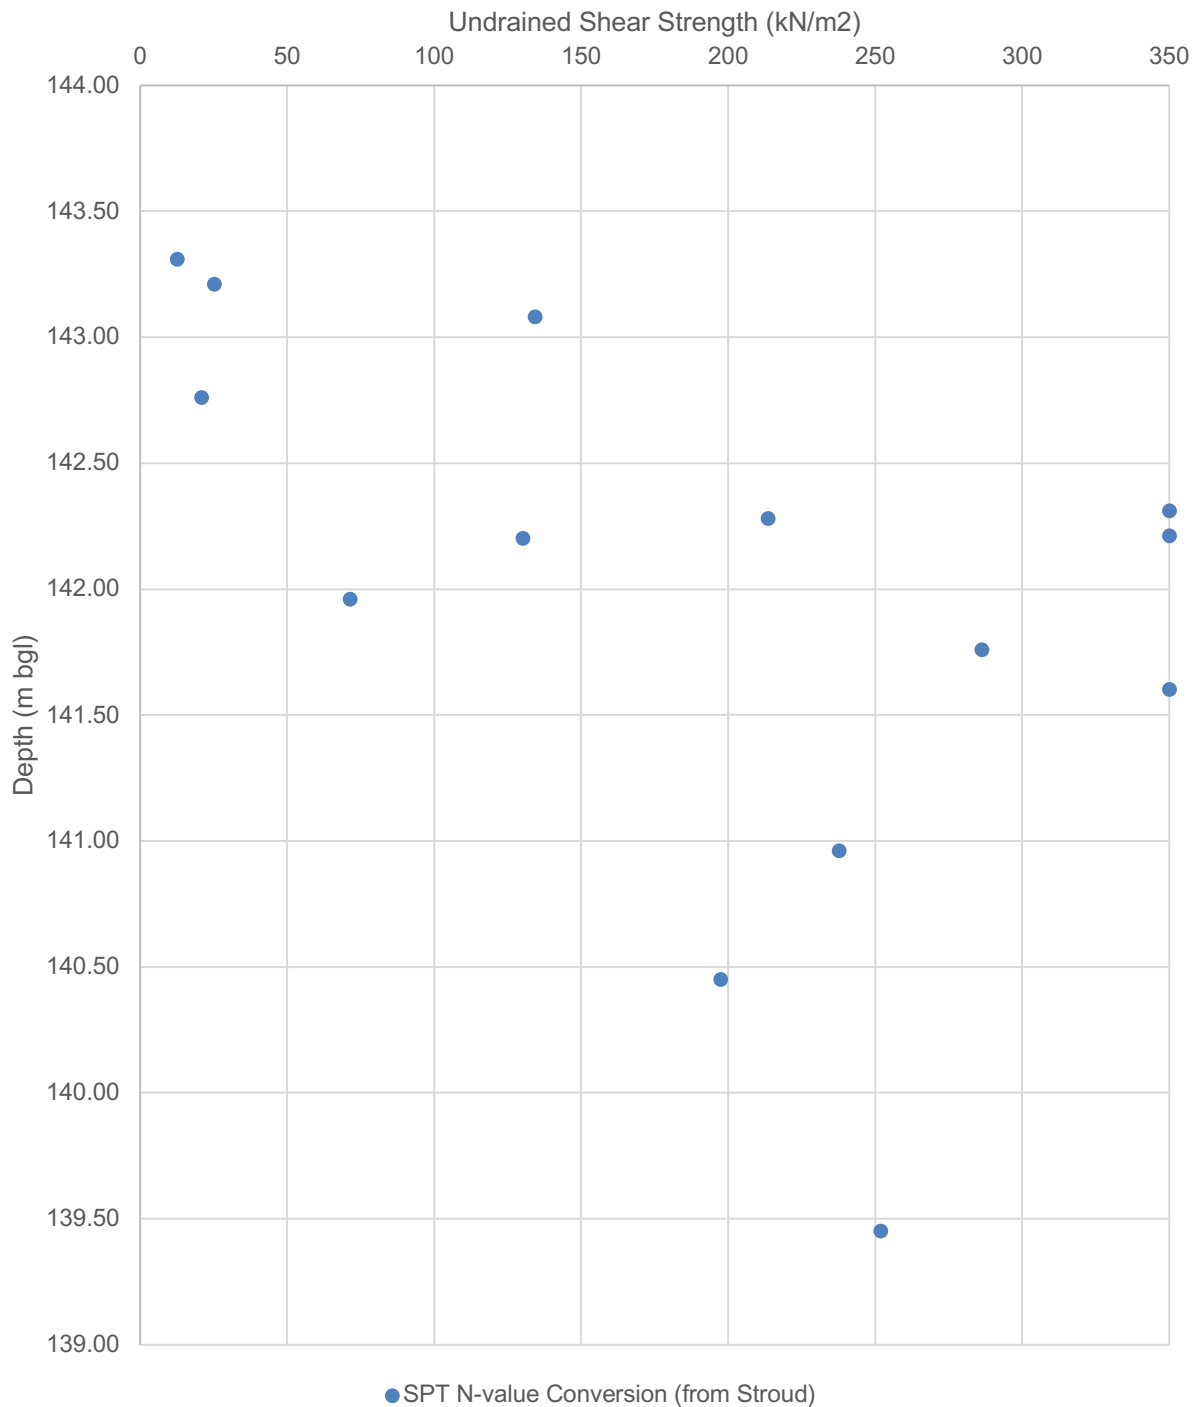
A Plasticity Index of 24% has been assumed (based on geotechnical laboratory testing), which equates to an f_1 factor of 5.0.

Graph 2: Plot of Mass Shear Strength Versus Depth

Note: Corrected Shear Strength plotted at a maximum of 350 KPa.

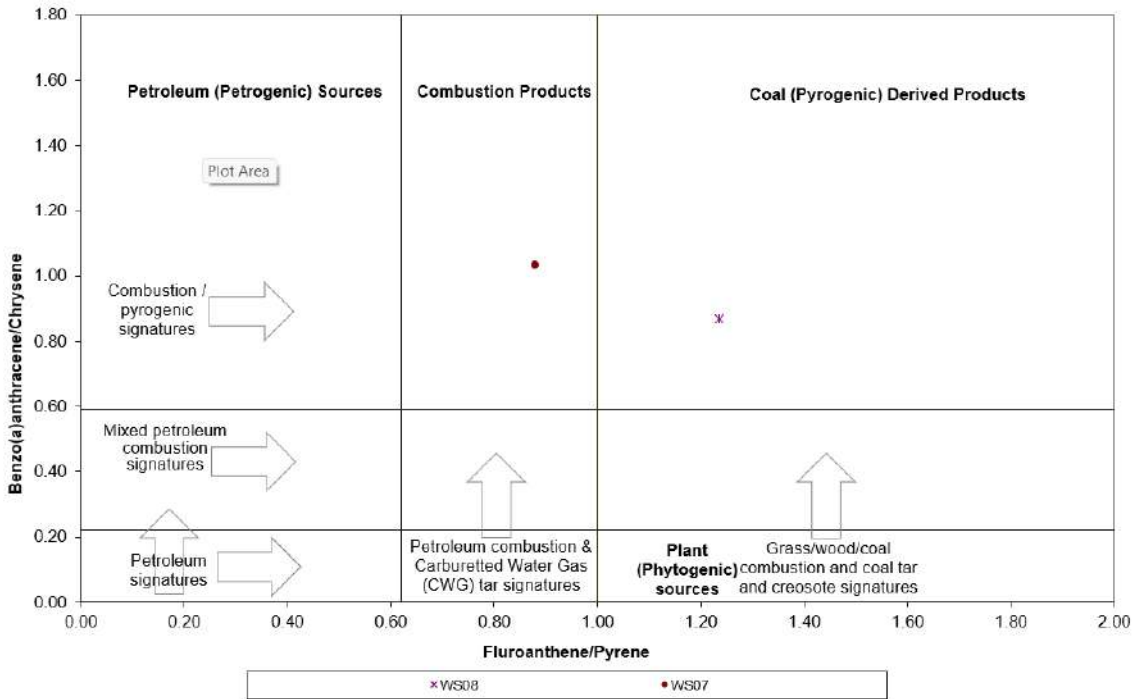
Concentrations of Polyaromatic Hydrocarbons (PAHs) were recorded above MDL in four of the five samples analysed, with a maximum concentration of 15.1 mg/kg recorded in WS8 at 0.2m bgl. In addition, the PAH concentrations have been plotted on a double ratio plot to provide an indication of the likely source of the PAHs. All of the samples that had detections of the four PAHs used have been

plotted, and all are indicated to be combustion or pyrogenic-related PAHs, which could be associated with urban background sources.

Graph 3: PAH Double Ratio Plot

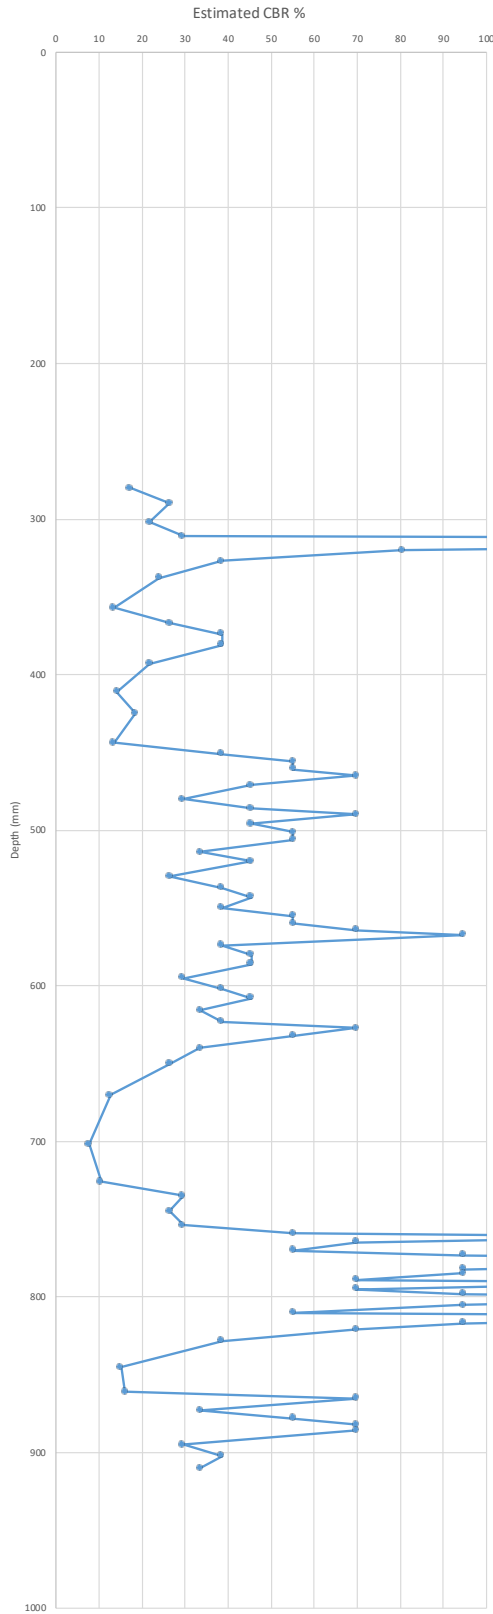
Notes: DCP test undertaken within location of WS1 once existing surfacing had been cored out.

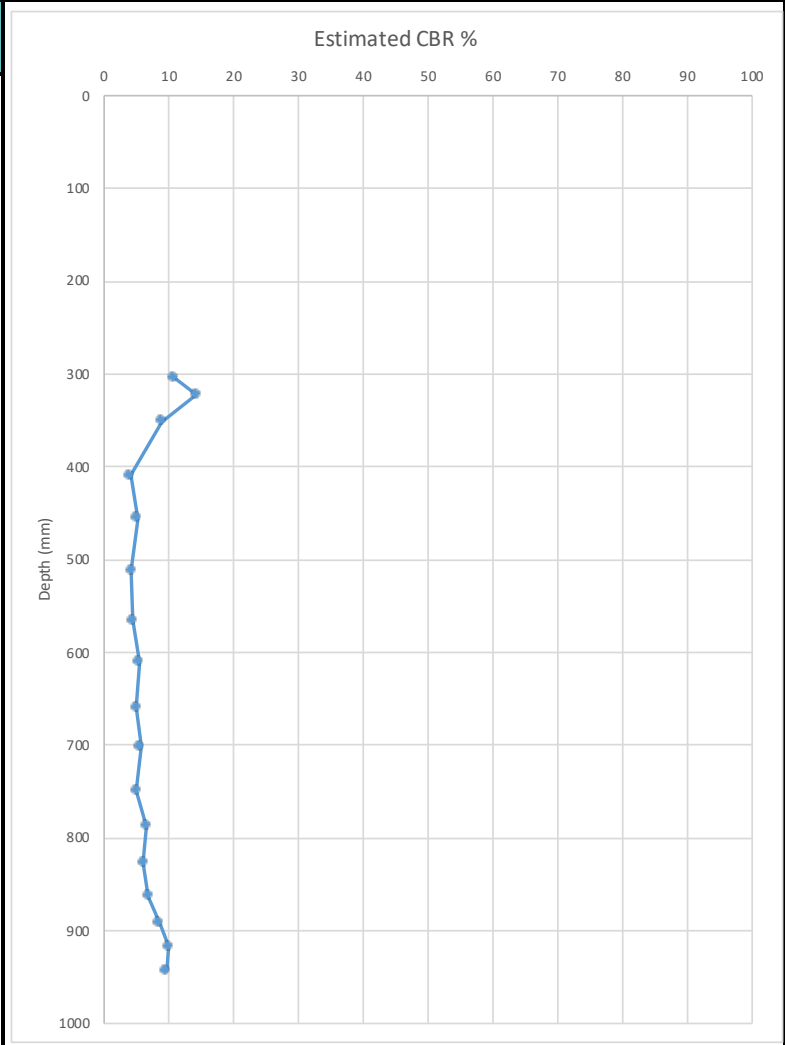
Notes: DCP test undertaken within location of WS2 once existing surfacing had been cored out.

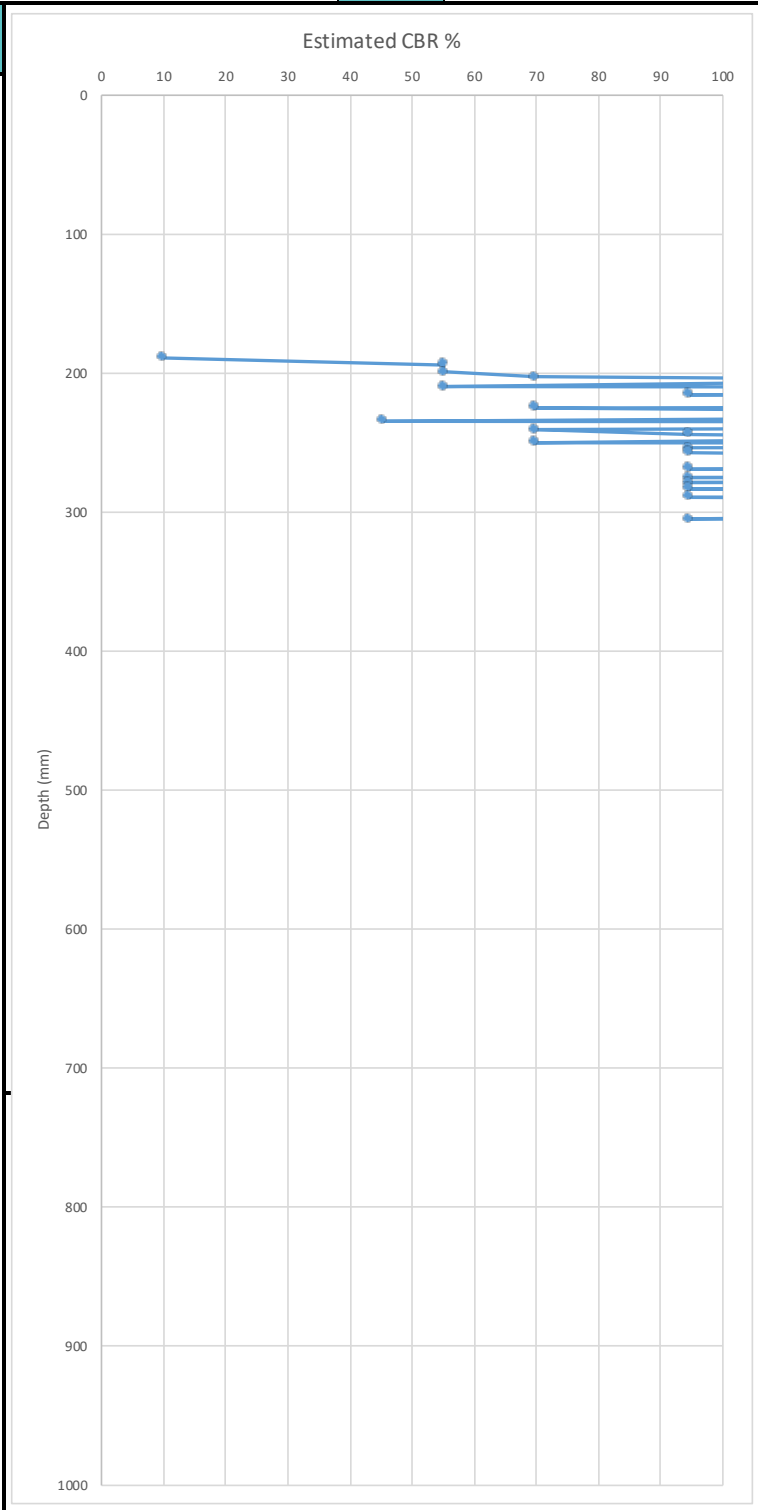
Notes: DCP test undertaken within location of WS5 once existing surfacing had been cored out.

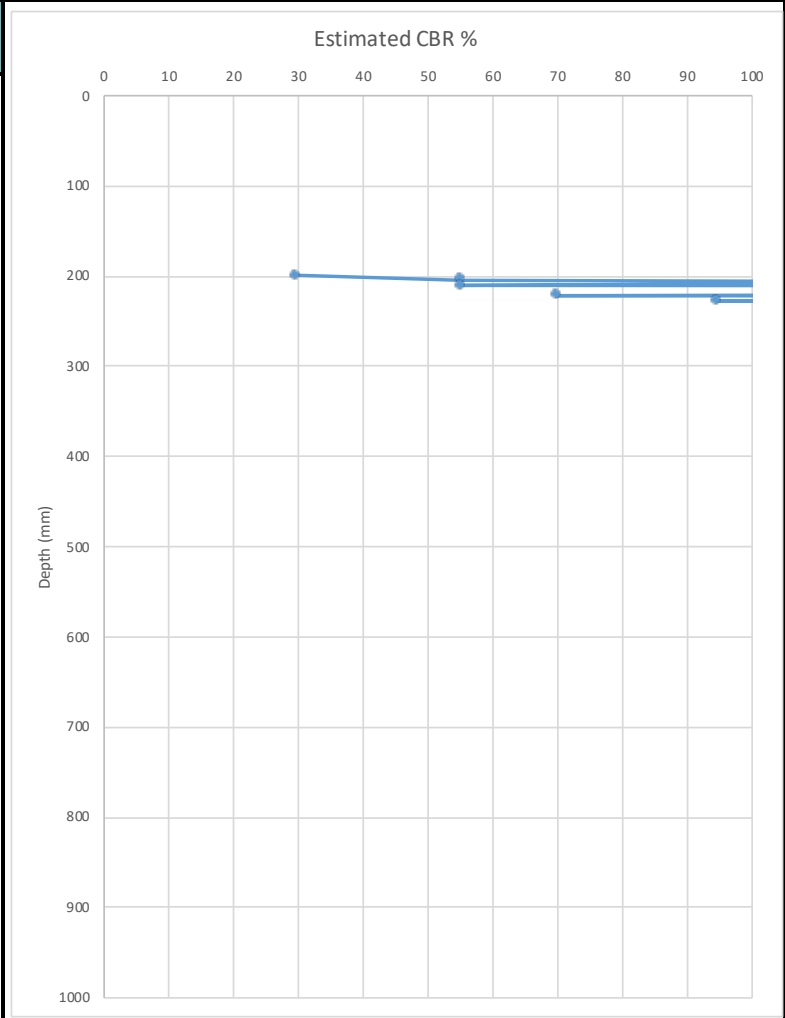
Notes: DCP test undertaken within location of WS7 once existing surfacing had been cored out.

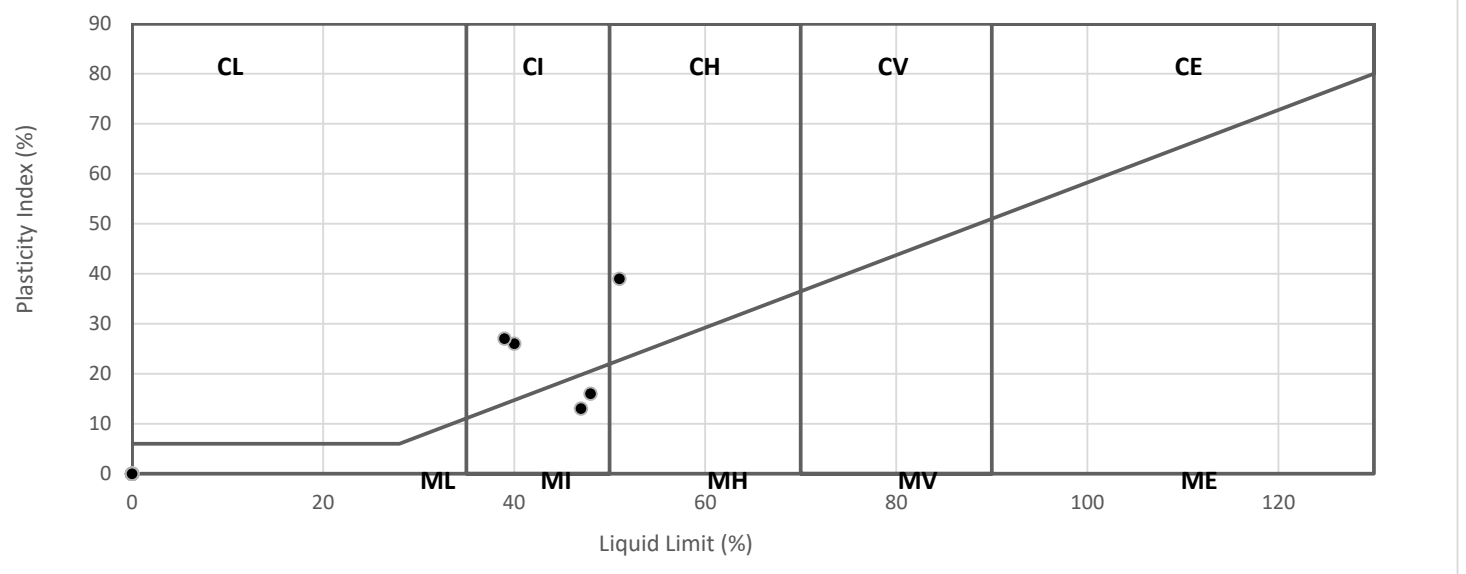
PLASTICITY CHART FOR CASAGRANDE CLASSIFICATION
BS 5930:2015+A1:2020

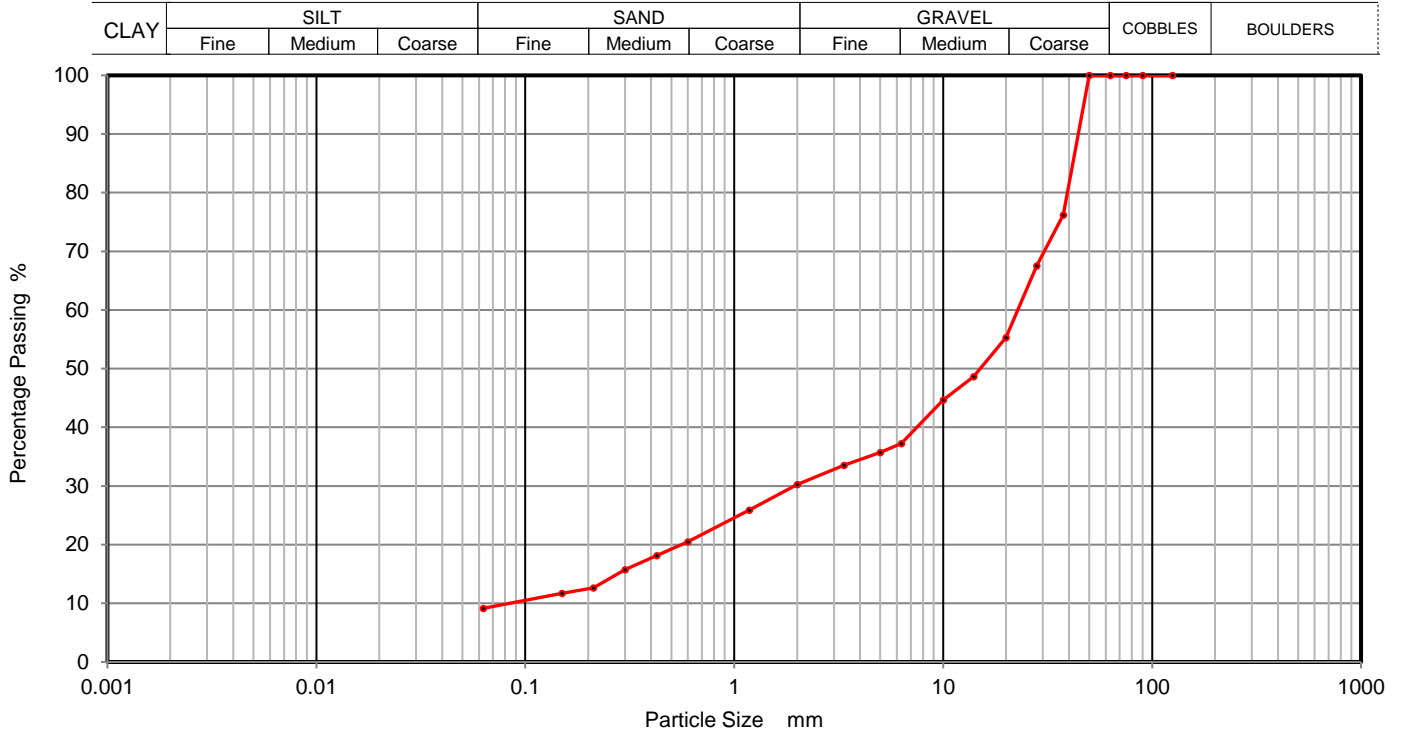
Contract Number	75525
Borehole/Pit No.	WS03A
Sample No.	
Depth Top	0.22
Depth Base	1.30
Sample Type	B

Project Name	Blackwood
Sample Description	Brown slightly silty/ clayey fine to coarse sandy fine to coarse GRAVEL
Date Tested	28/10/2024

Sample Proportions	% dry mass
Cobbles	0
Gravel	70
Sand	21
Silt and Clay	9

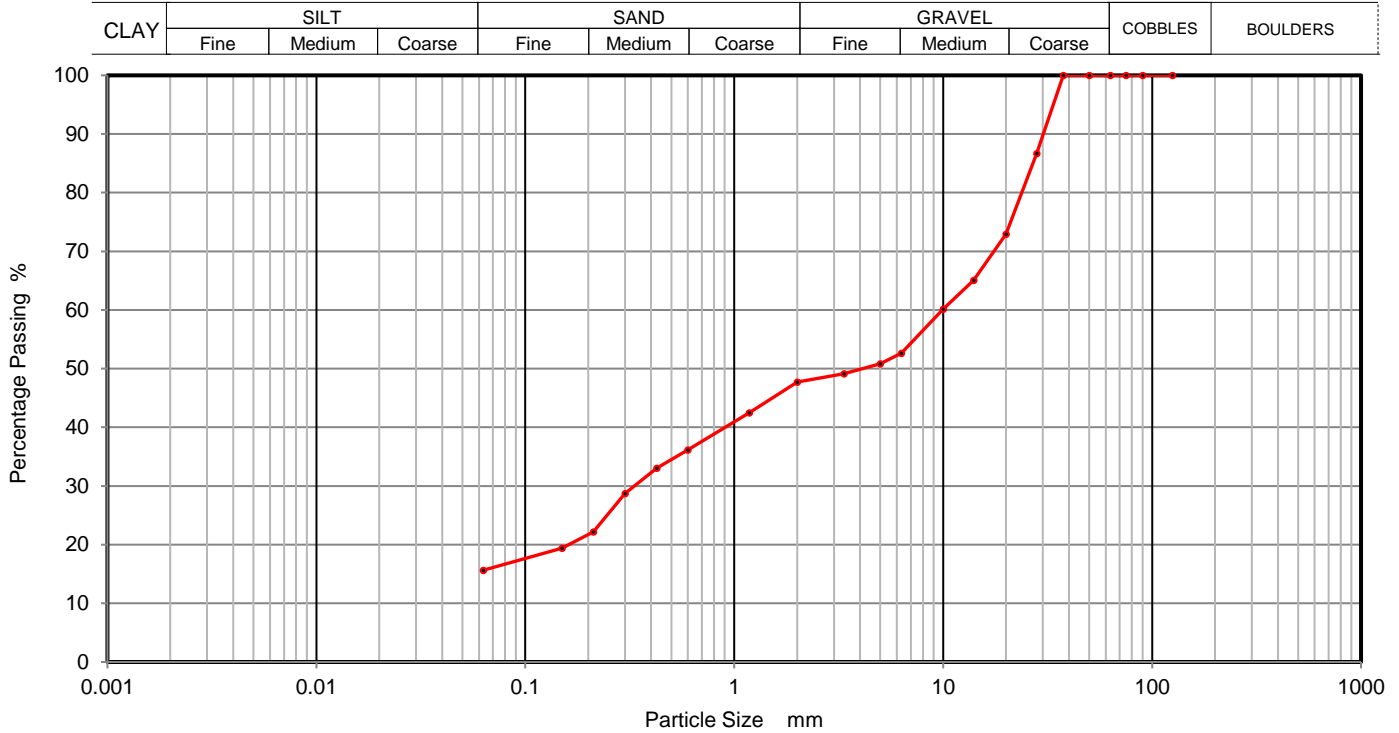
Contract Number	75525
Borehole/Pit No.	WS06
Sample No.	
Depth Top	0.60
Depth Base	1.00
Sample Type	B

Project Name	Blackwood
Sample Description	Brown silty/ clayey fine to coarse sandy fine to coarse GRAVEL
Date Tested	28/10/2024

Sample Proportions	% dry mass
Cobbles	0
Gravel	52
Sand	32
Silt and Clay	16

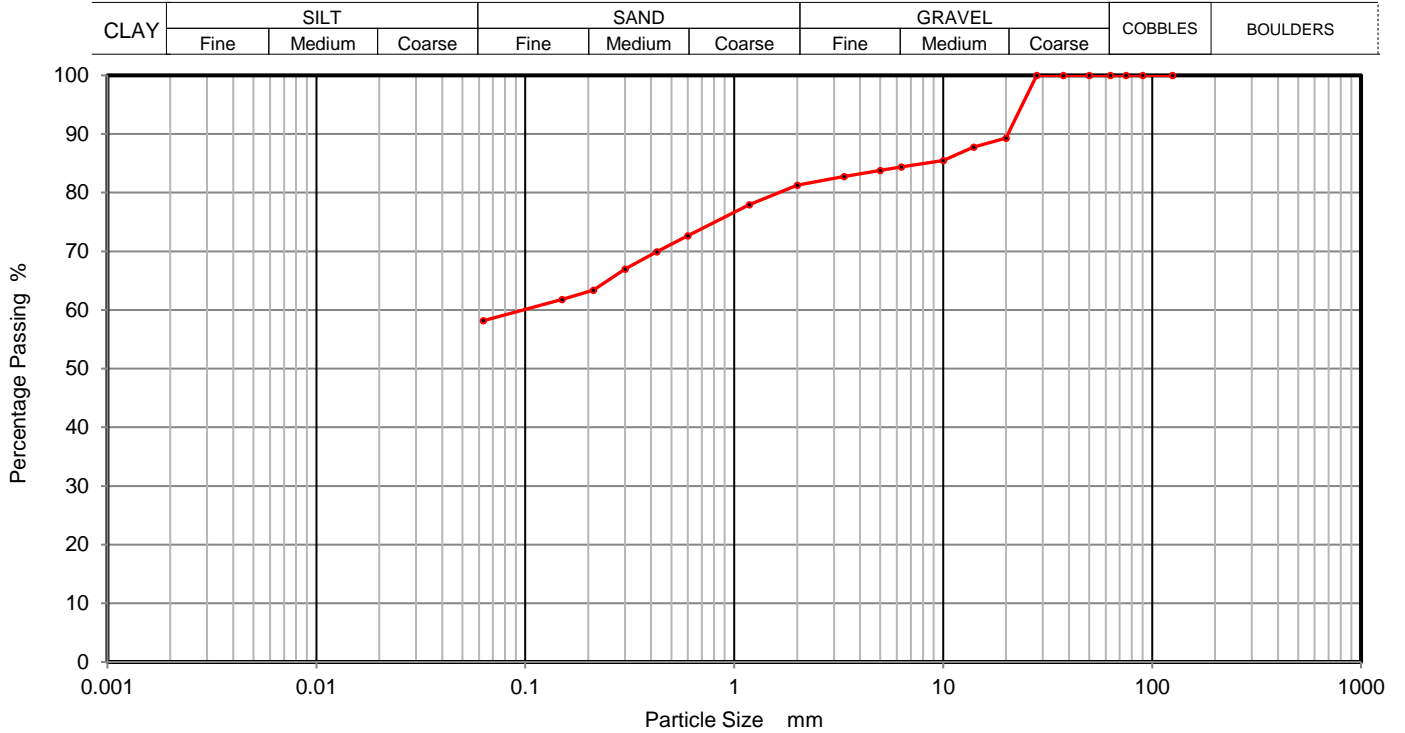
Contract Number	75525
Borehole/Pit No.	WS09A
Sample No.	
Depth Top	1.10
Depth Base	1.80
Sample Type	B

Project Name	Blackwood
Sample Description	Brown fine to coarse gravelly fine to coarse sandy SILT/ CLAY
Date Tested	28/10/2024

Sample Proportions	% dry mass
Cobbles	0
Gravel	19
Sand	23
Silt and Clay	58
