# Coal Mining Risk Assessment

Client: Lidl Great Britain Ltd

Stagecoach Depot,  
Penmaen Road, Blackwood

Report No: 1271.02.01

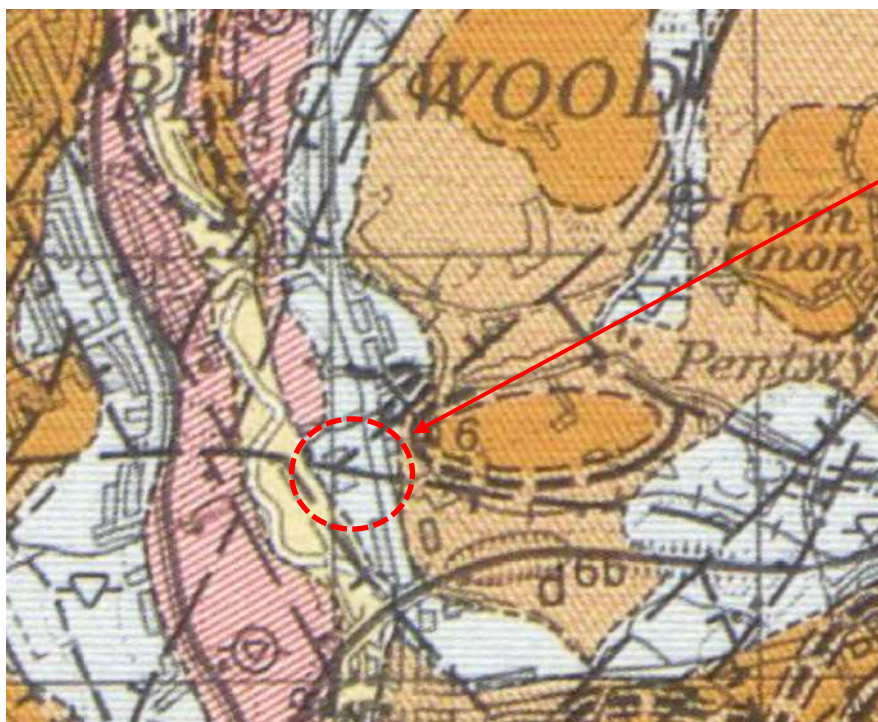
Extract of BGS Sheet 249 – Newport, 1997 (Solid & Drift)

The bedrock underlying the superficial deposits is formed of the Grovesend Formation. The BGS describes the stratum as typically comprising 'predominantly argillaceous, comprising mudstones and siltstones, with well-developed coals; minor lithic ("Pennant") sandstones; locally developed red mudstones in the type area.'

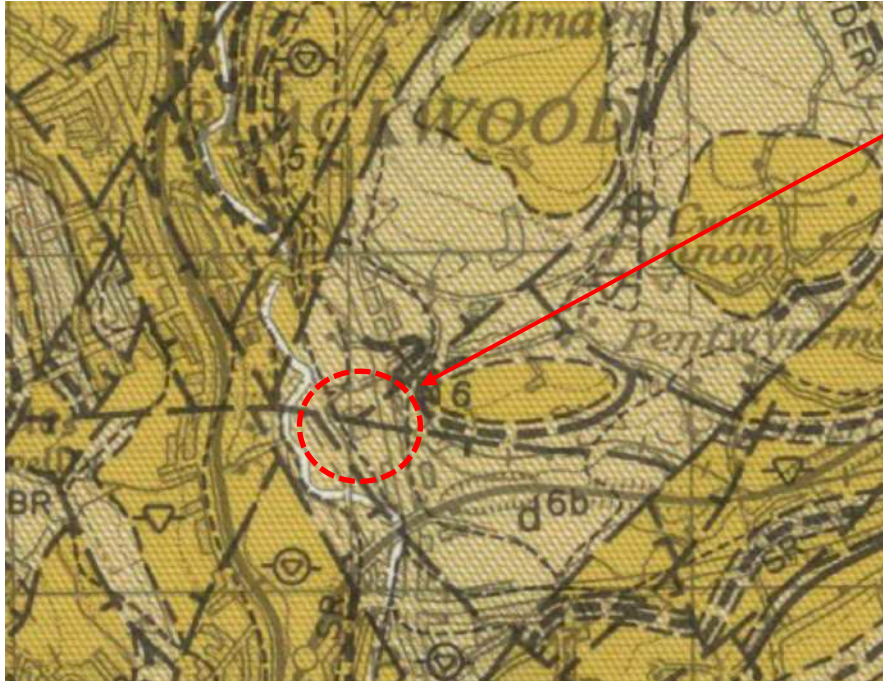
Study Site

Extract of BGS Sheet 249 – Newport, 1986 (Solid)

The 1:50,000 series BGS map sheet 249 (Newport) dated 1986 indicates that the site is bisected by a WNW-ESE orientated fault in the northern area, which downthrows towards the south. The BGS mapping also shows a NE-SW orientated fault joining this WNW-ESE fault on-site, downthrowing towards the north-west. However, the Envirocheck report obtained for the study site indicates this to be present immediately to the north of the site and joining the WNW-ESE fault adjacent to the north-western corner, as shown in the extract below:

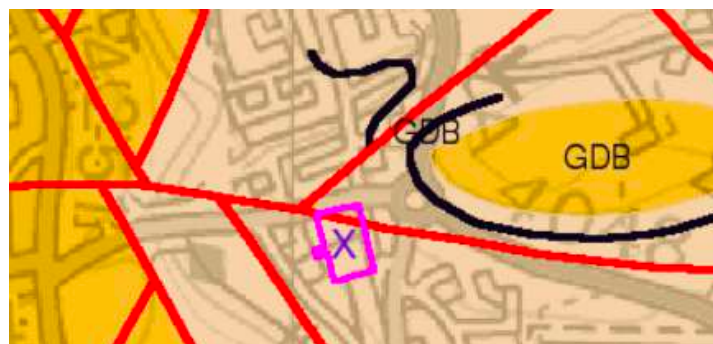
Extract from Envirocheck Report showing faulting on and around the site
