# 8 ANNEX - SUPPORTING INFORMATION

8.2 Hydrology Methodology and NRW Correspondence

# 15679 – Land at Pontymister, Risca Proposed hydraulic modelling methodology for NRW comment – Existing NRW Model Build

We are currently undertaking hydraulic modelling of the River Ebbw through Risca to inform a Flood Consequences Assessment for a proposed commercial development site at Commercial Street, Risca, Newport, NP11 6EE (NGR: 324398, 189871). A location plan and aerial image is included in Appendix A.

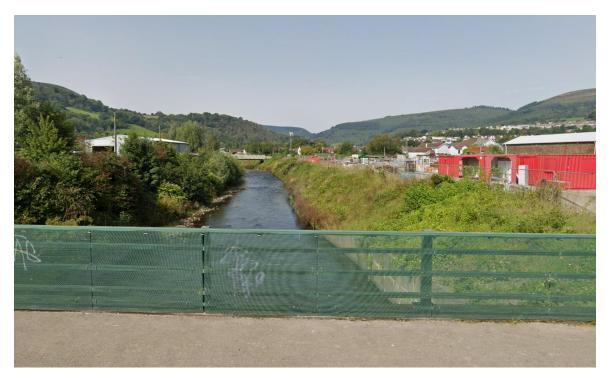
Streetview Image at the road bridge on the B4591 (NGR 324437, 189789) facing upstream (adjacent to site boundary). Image extracted on 24/10/2024.

Blockage scenarios based on the latest NRW blockage guidance document will be carried out simulating a 25% blockage of the B4591 Road Bridge (at approximately NGR: 324440, 189784) during the 1% AEP plus CC1, 1% AEP plus CC2 and 0.1% AEP events only. A 25% blockage has been deemed applicable due to the size of the bridge.

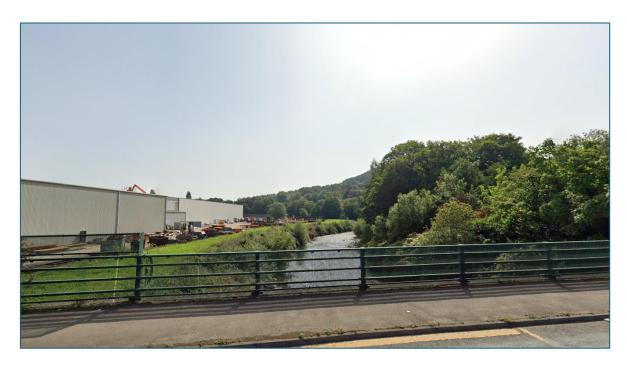
Streetview Image at the road bridge on the B4591 (NGR 324437, 189789) facing downstream (adjacent to site boundary). Image extracted on 24/10/2024.

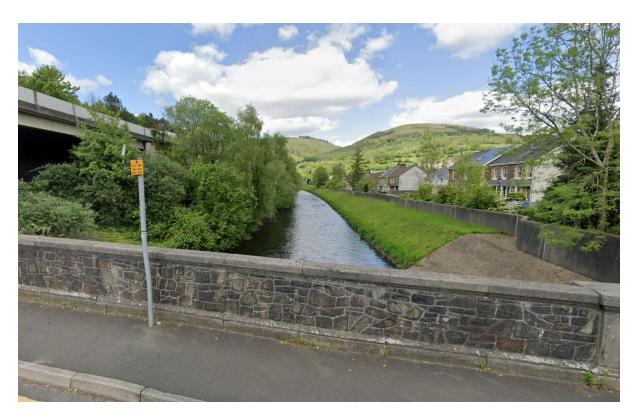
Streetview Image at the bridge on Dan y Graig Road (NGR 323621,190544) facing upstream. Image extracted on 24/10/2024

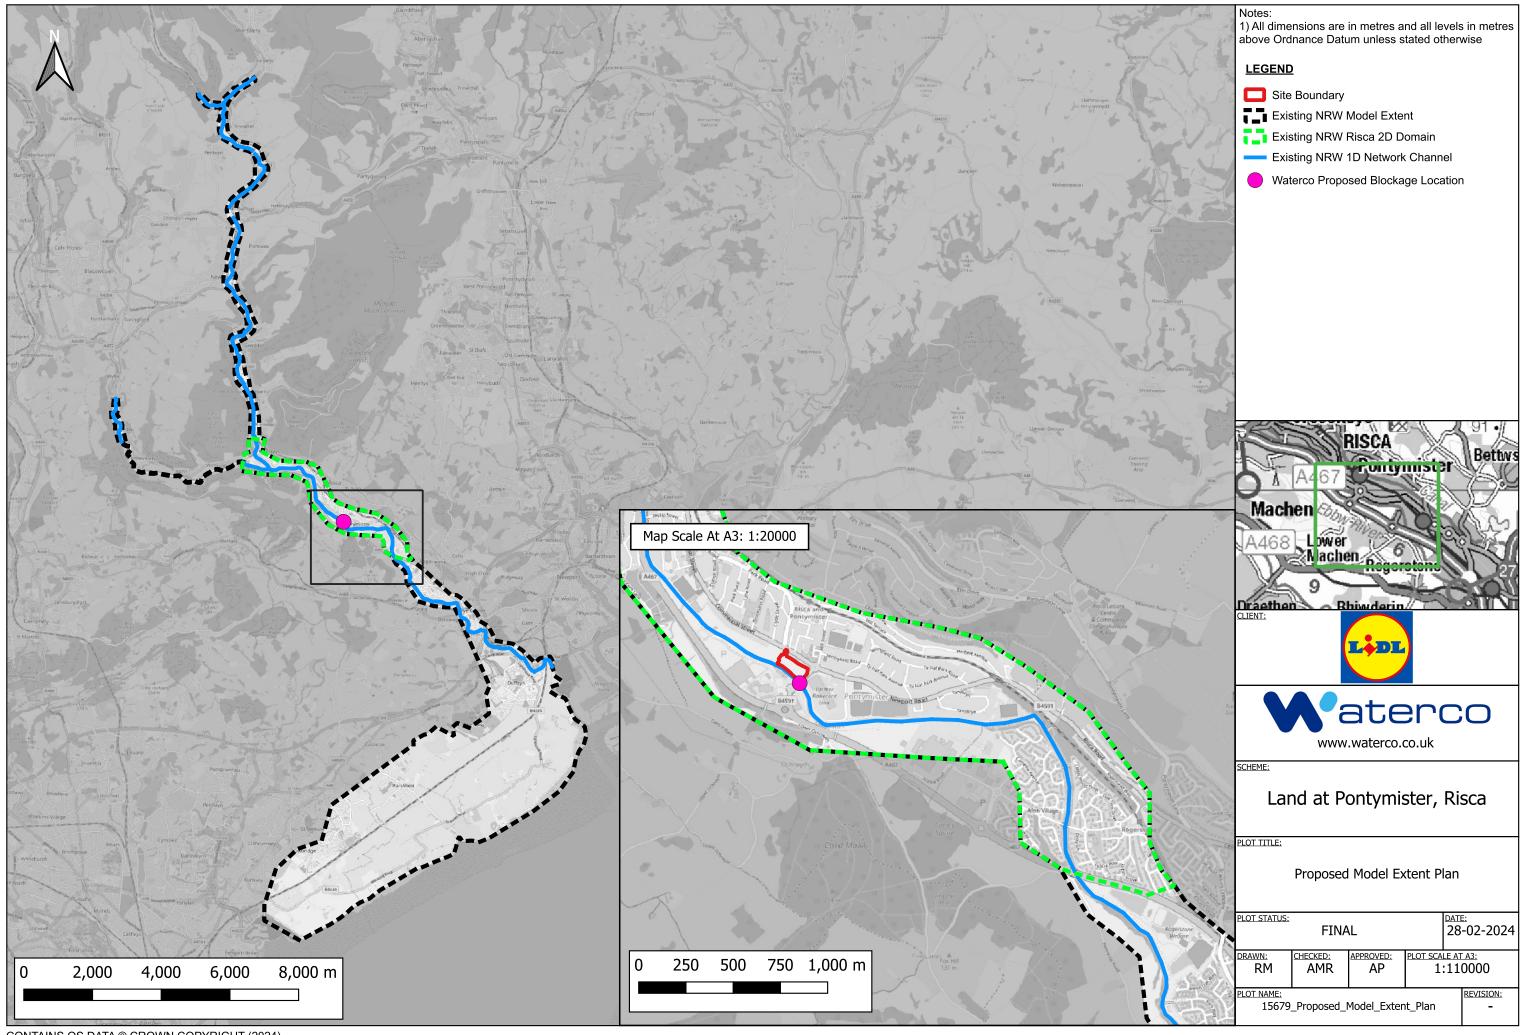
# **Appendix B** Proposed Model Extent

Extent: Please find the model extent included in Appendix B.

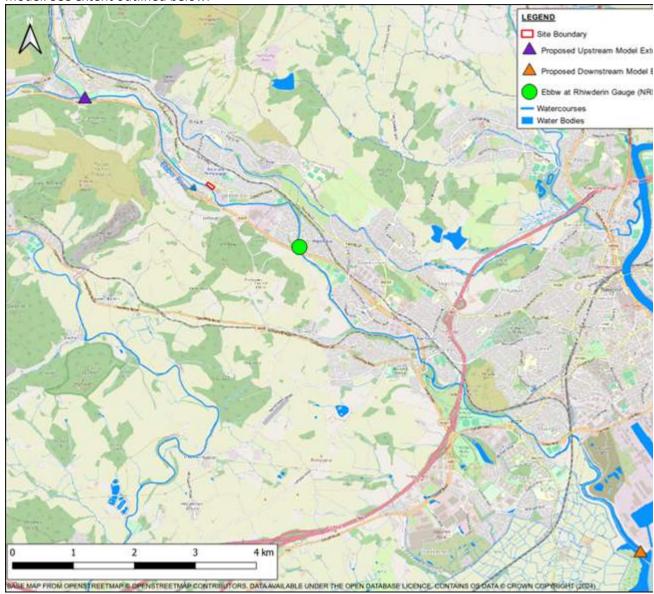
Model extent - the upstream extent of the hydraulic model will be truncated to the confluence between the Ebbw River and the Sirhowy River. The downstream extent of the model is to be maintained as per the NRW model. See extent outlined below.

- Due to the locations of the upstream and downstream boundaries of the hydraulic model and the large catchment area (>200km²), a single inflow will be required for the hydraulic model.

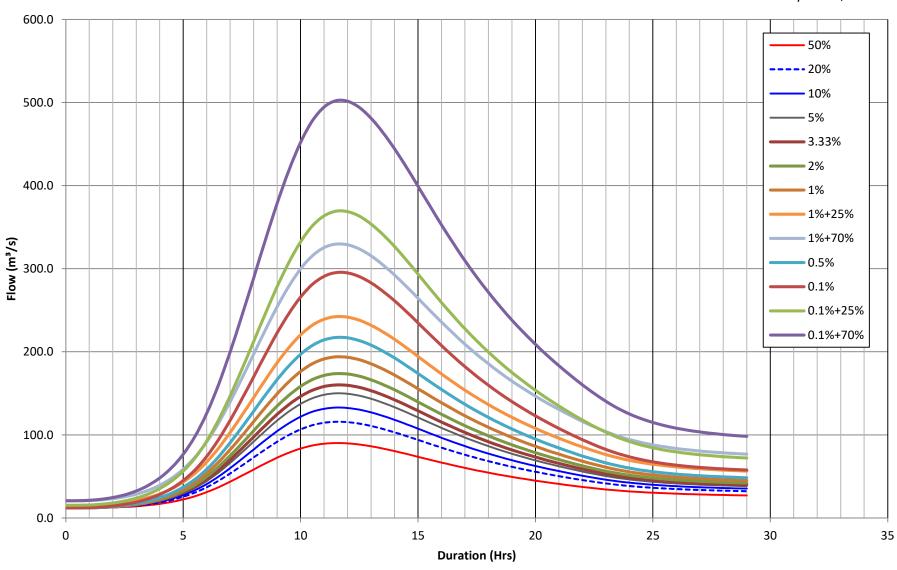
# **Design Hydrographs (ReFH2)**

#### **Ebbw River**

- The results will be compared with historical flood records and the AMAX data on record.
- The two methods investigated will be ReFH2 and FEH Statistical Enhanced Single Site. ReFH2 will unlikely be the chosen method to produce the final peak flows due to the seemingly reliable gauge near to the site.
